Report : 080923/008. Trimaran.

Boat : Trimaran "CXXXXX".

Subject : Expertise Controls underside of the three hulls.

EXPERT REPORT

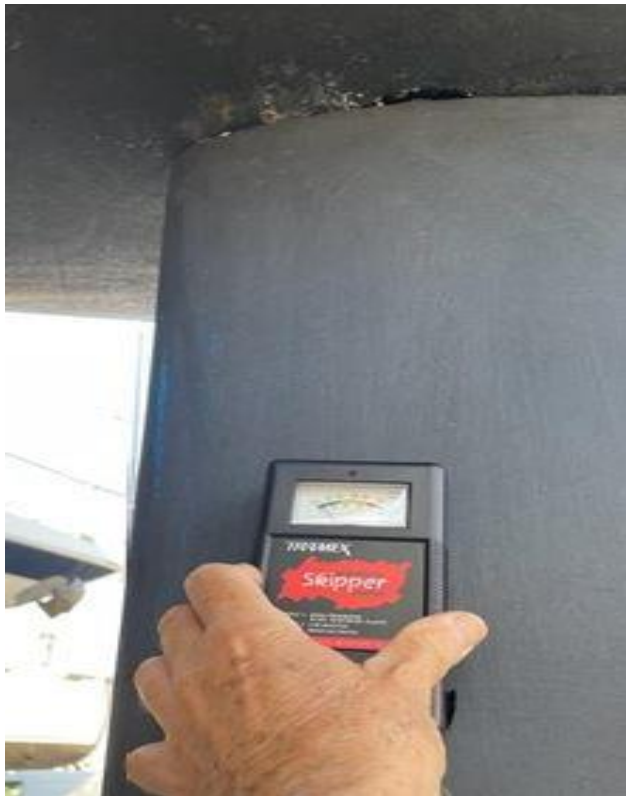
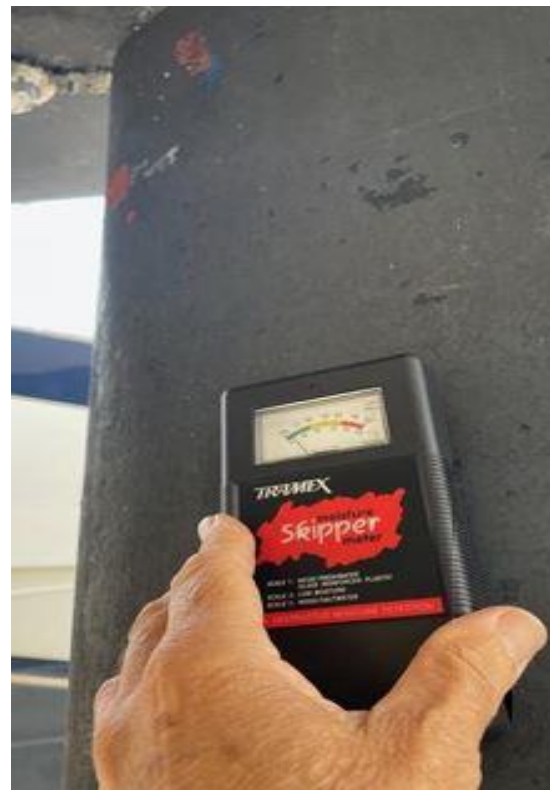
All sensitive areas of the 3 hulls – seacocks, shafts, rudders, keels - are free of osmosis/humidity except starboard rudder (slight moisture)

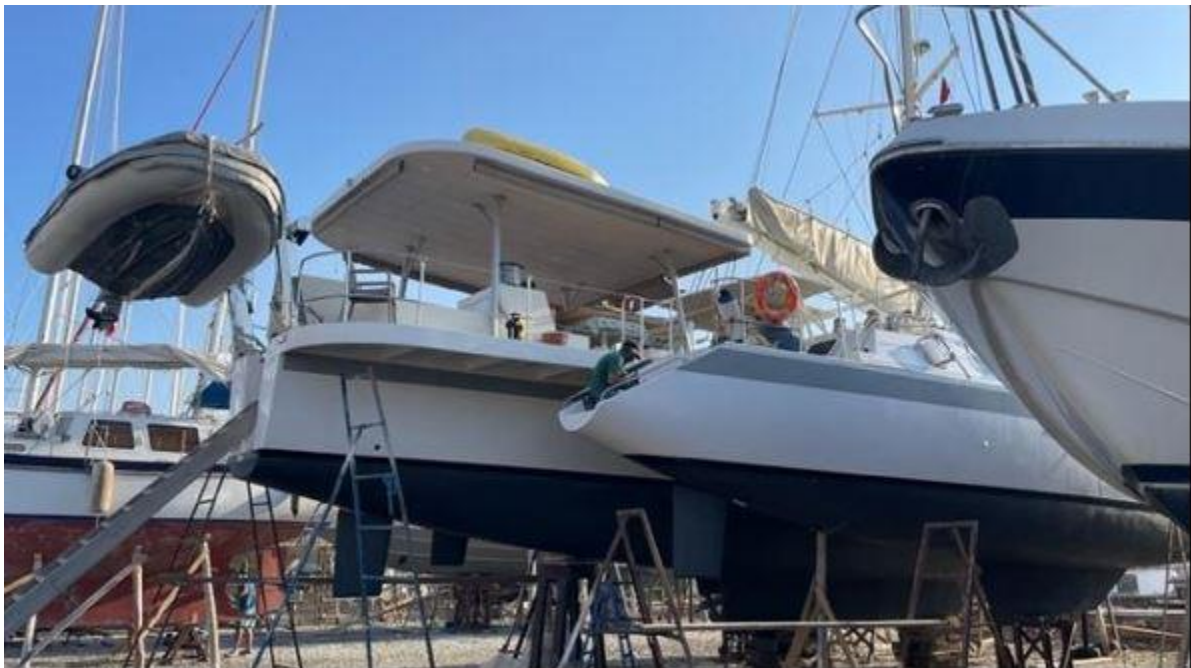
starboard rudder (slight moisture)
